**Structural Inspection and
O&M, Occupational and Public Safety Review
of the
Hot Springs Tunnel System,
Hot Springs National Park
Hot Springs, Arkansas**

August, 1993

Bureau of Reclamation
Denver Office

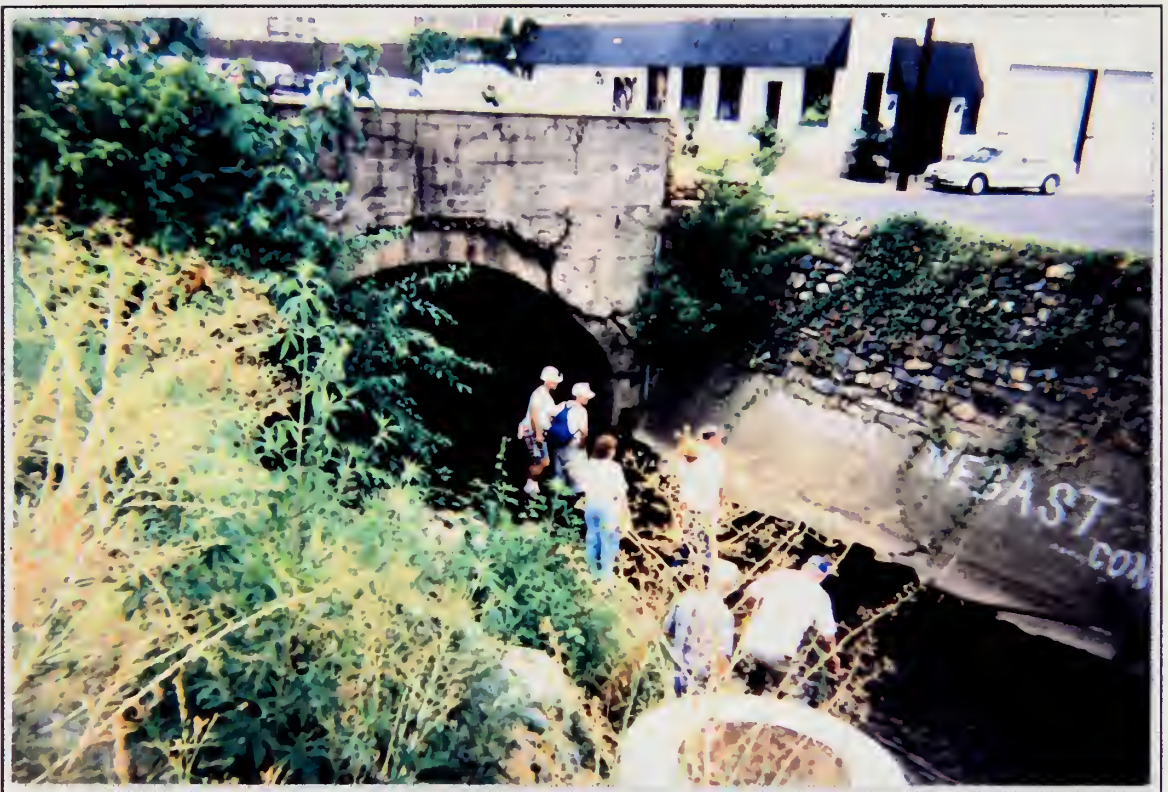
The morning of August 3, those inspecting the tunnel entered the Arch Creek Tunnel at the outlet (about Station 183+00 on Figure 2.3). Photo 3.1 shows the headwall of the outlet.

3.1 Inspection party entering the outlet of Arch Creek Tunnel.
 (About Station 183+00 COE Drainage Map Figure 2.3)

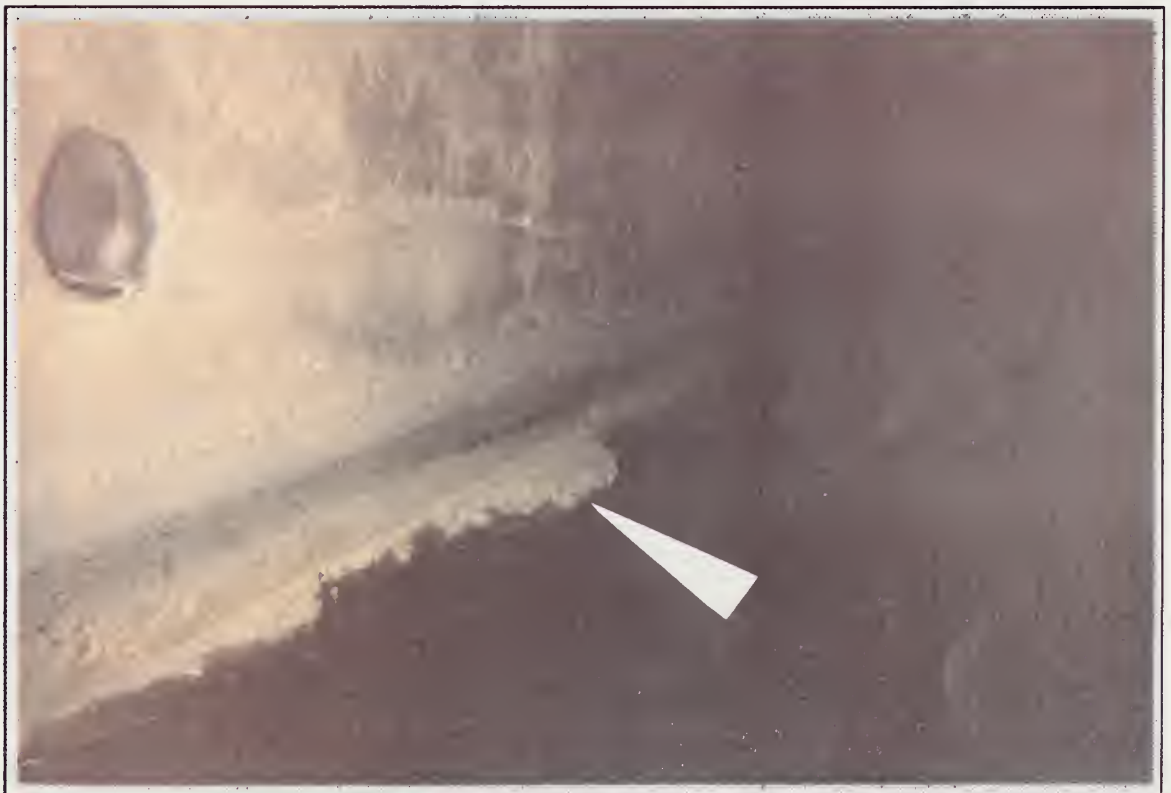
In the outlet reach the Arch sidewalls are founded on a shale rock unit. Significant undermining of the sidewalls was noted in this reach. Photos 3.2 and 3.3 show erosion at the base of the sidewalls and in the invert of the tunnel.

3.2 Sidewall of the Tunnel. The base of the sidewall has been severely undercut. The concrete traces the base of a previous repair. (About Sta. 187+00.)

1993-T2-2 Complete an engineering inspection of the entire tunnel system. Prepare drawings showing all pipe connections and piping systems in the tunnel. Show all exhibiting structural anomalies. Prepare a specification for repair of the undercutting of the sidewalls of the tunnel.

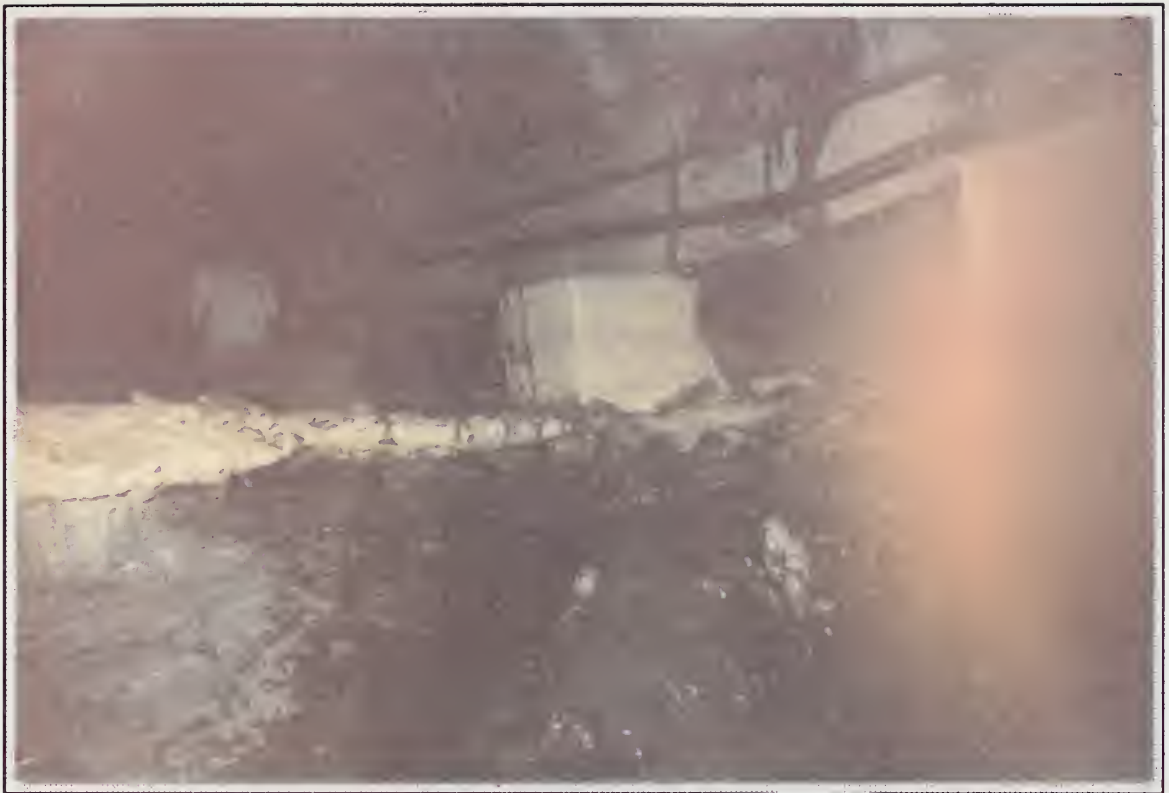
3.3 Pedestal and Erosion of the Tunnel Invert (About Sta. 190+00)

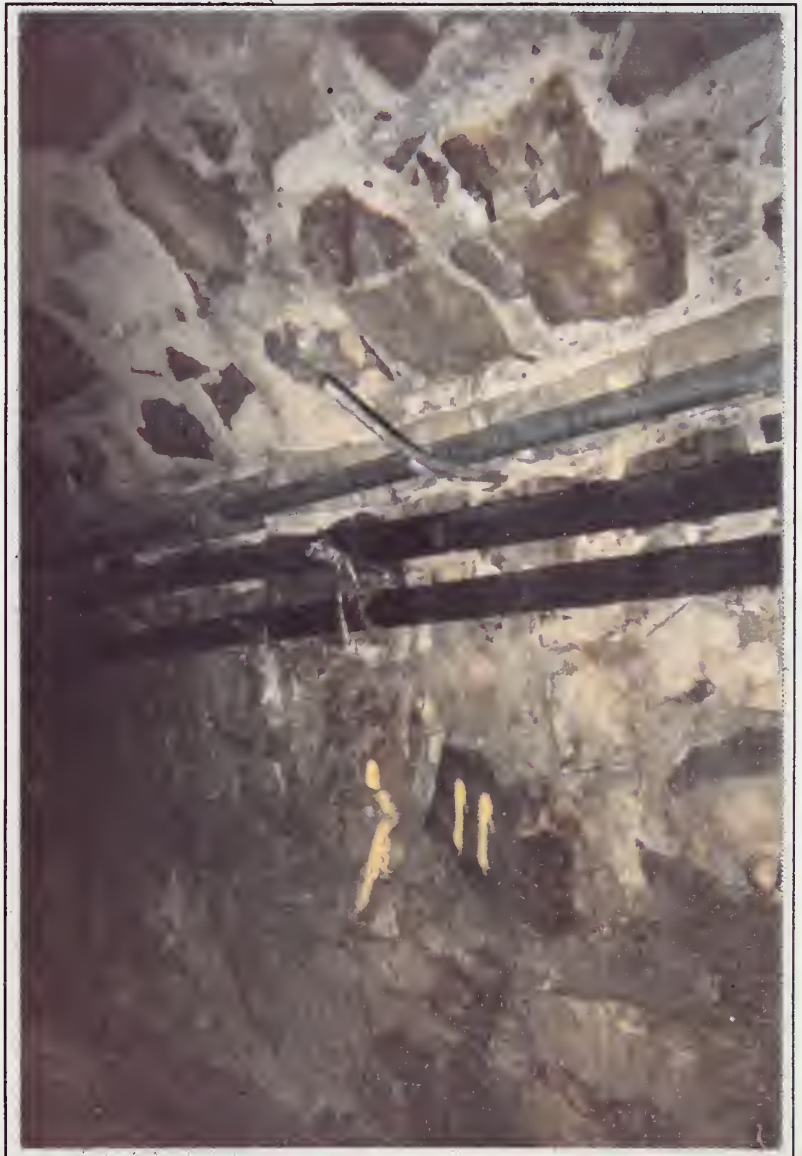
In general the arch appeared to be in good condition loose rock blocks were observed in the sidewalls where the foundation had been undermined, however; the arch and sidewalls usually appeared to be well cemented without loose blocks. Photo 3.4 shows the arch and sidewall of the tunnel. The painted number on the sidewall may be related to a recent Corps of Engineers survey in the tunnel.

3.4 Arch and Sidewall. (About Sta. 200+00)

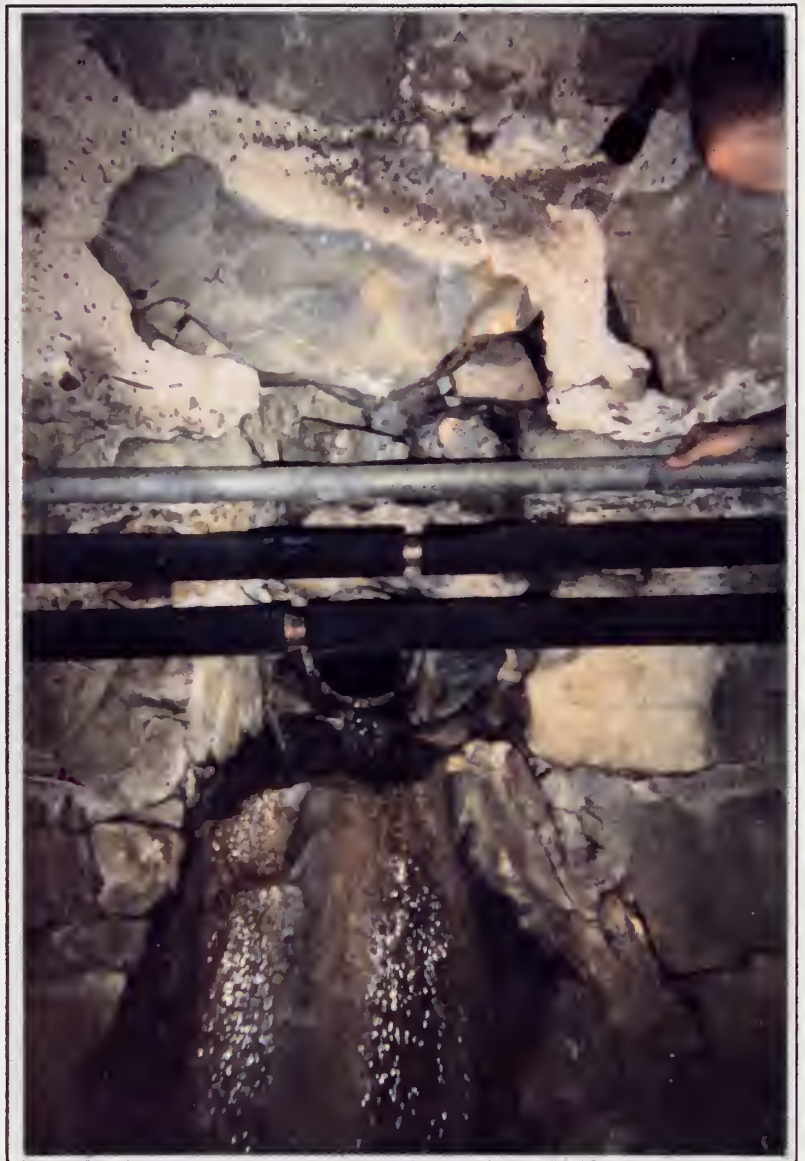
Throughout the tunnel openings in the arch and sidewalls are evident. Photo 3.5 shows a pipe entering the tunnel with water flowing down the sidewall of the tunnel. Photo 3.6 shows a wooden blockout in the crown of the tunnel.

3.5 Drainage Entering the Tunnel.
(About Sta. 205+00)

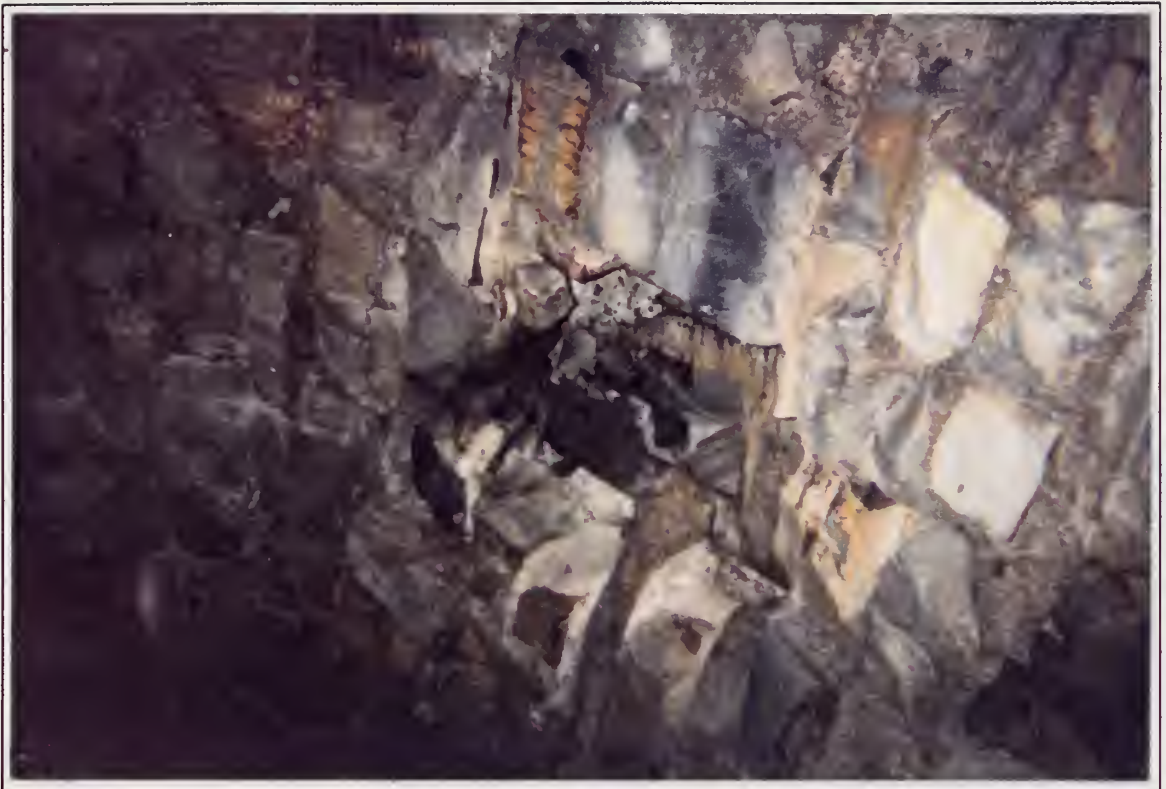
3.6 Crown of the Tunnel. Wooden blockout for drainage into the tunnel is visible in the crown. (About Sta. 200+00)

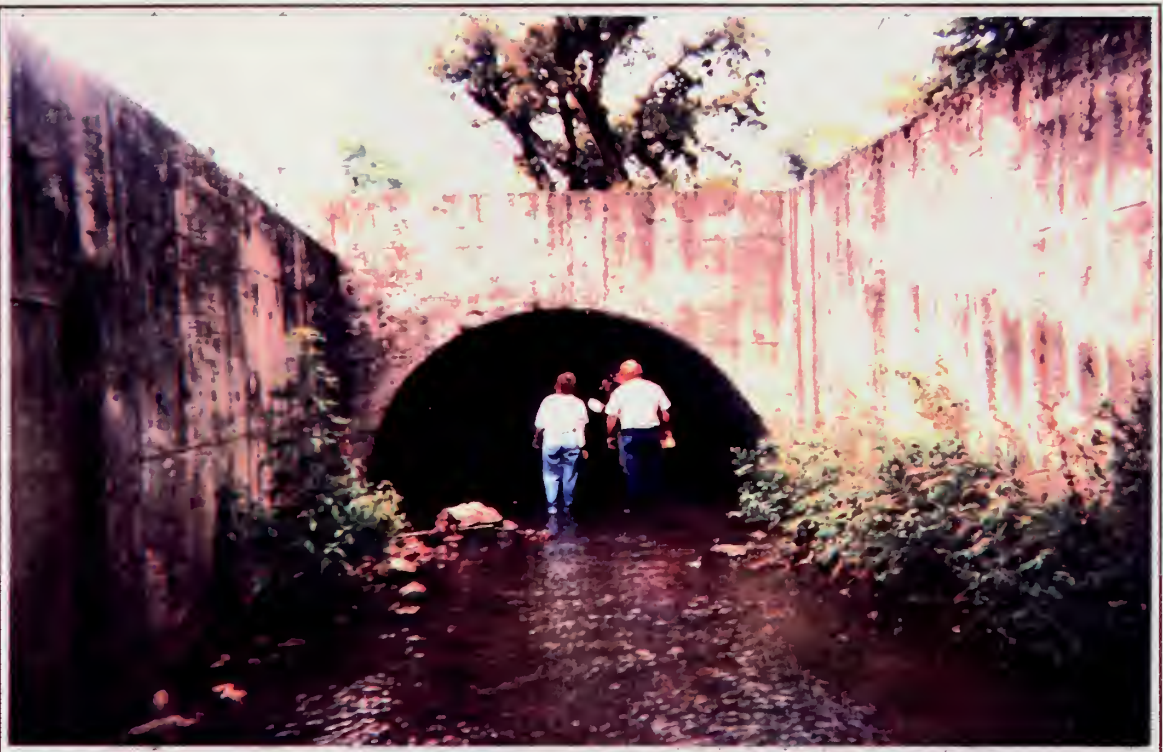
After lunch we entered the Whittington Avenue section of the tunnel. Photo 3.7 shows the tunnel entrance on the Whittington leg. A corrugated metal section extends a short distance into the tunnel.

3.7 Whittington Avenue Entrance. The structural steel plate is just visible inside the tunnel. (About Sta. 72+00 Whittington Ave Branch COE Map Figure 2.3)

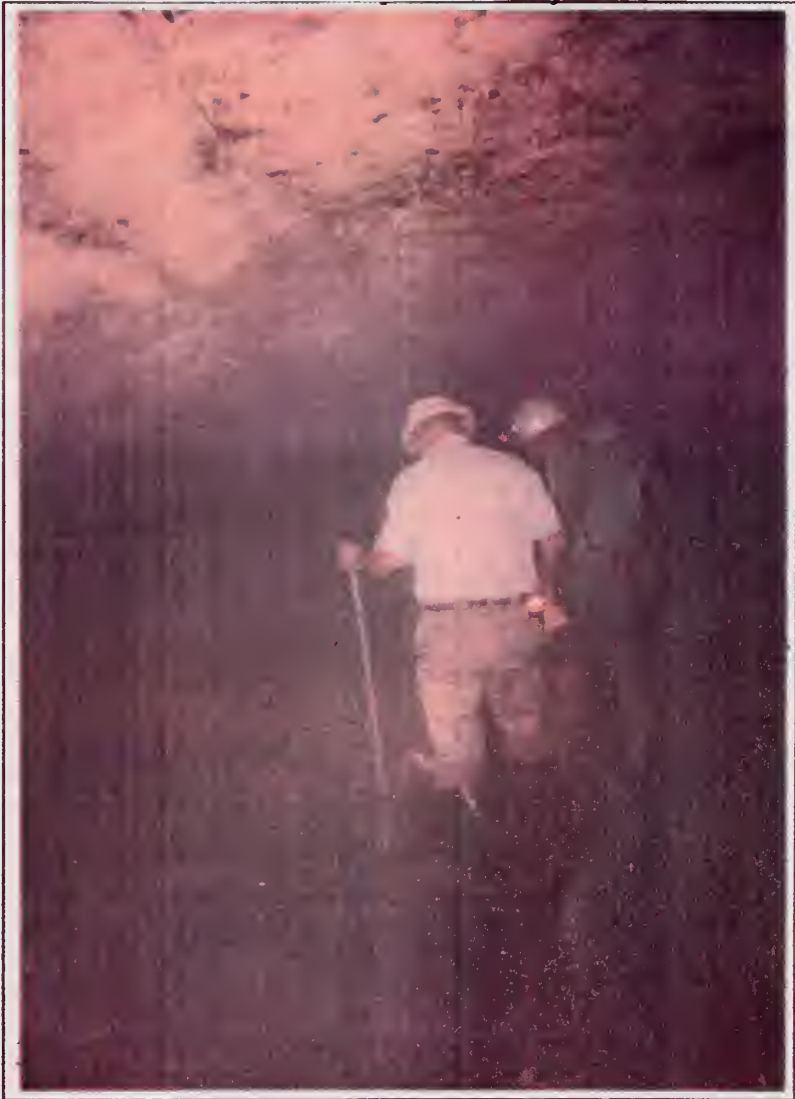
In some reaches the arch has been covered with shotcrete. Photo 3.8 shows a section of the tunnel with a sound shotcrete coating.

3.8 Tunnel Crown. Shotcrete or gunite treatment. (About Sta. 60+00 Whittington Branch)

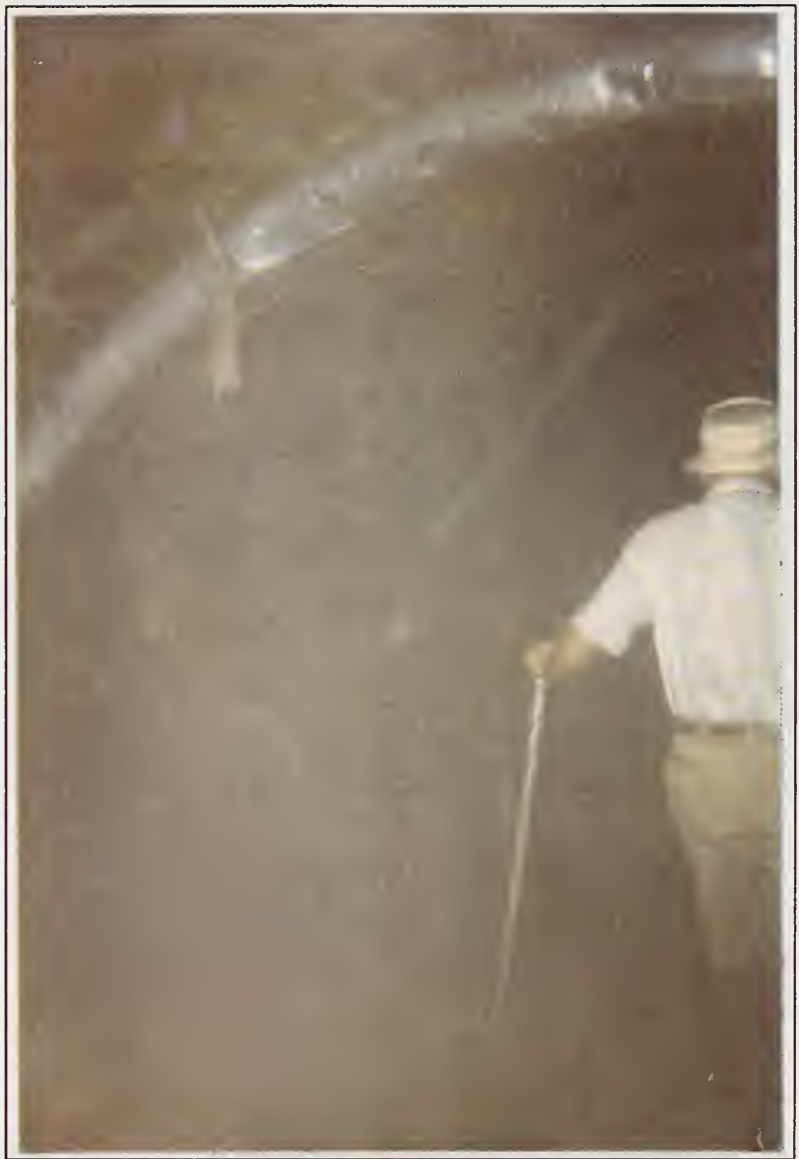
In the reaches of the tunnel near Hot Springs Mountain hot water collection and distribution pipes are supported on the sidewalls and occasionally cross the tunnel. Photo 3.9 shows a pipe across the arch.

3.9 Insulated Piping Crossing the Tunnel Crown.

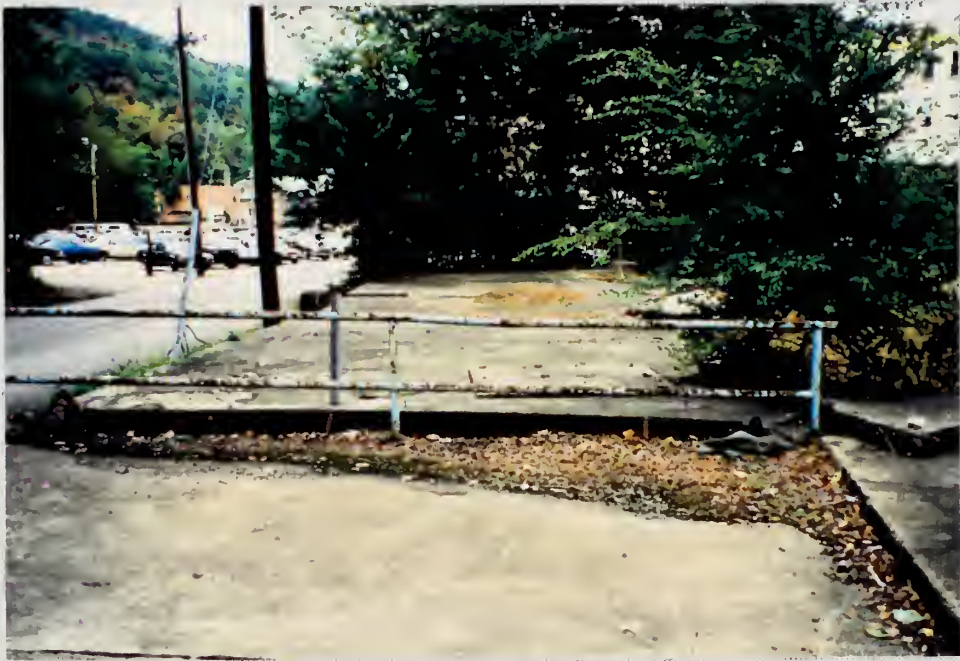
Near the intersection of Loadstone and Arbor Streets a concrete structure covers the tunnel. It is possible for vehicles to access the top of the structure which does not appear to be adequate to support vehicular traffic. The structure also contains unprotected openings to the tunnel below. This condition is a serious deficiency with significant public safety hazard potential

Photos 3.11 and 3.12 were taken from the surface after we exited the tunnel. The area is one of immediate concern. After we observed a somewhat haphazard arrangement of structural steel beams and pipe bracing in the tunnel, we inspected the surface to find the remains of an old structure with unprotected openings to the tunnel. The concrete structure was a thin slab supported by the steel beams we observed in the tunnel. It appeared that vehicles could park on the slab. We discussed the apparent danger with the city representative Dave Stanage on the spot. Structural modifications to this area are needed.

3.11 Vault near Arbor and Loadstone Streets. (About Sta. 238+00)

1993-T1-1. Fence the vault area near the intersection of Loadstone and Arbor streets and cover openings to the tunnel.

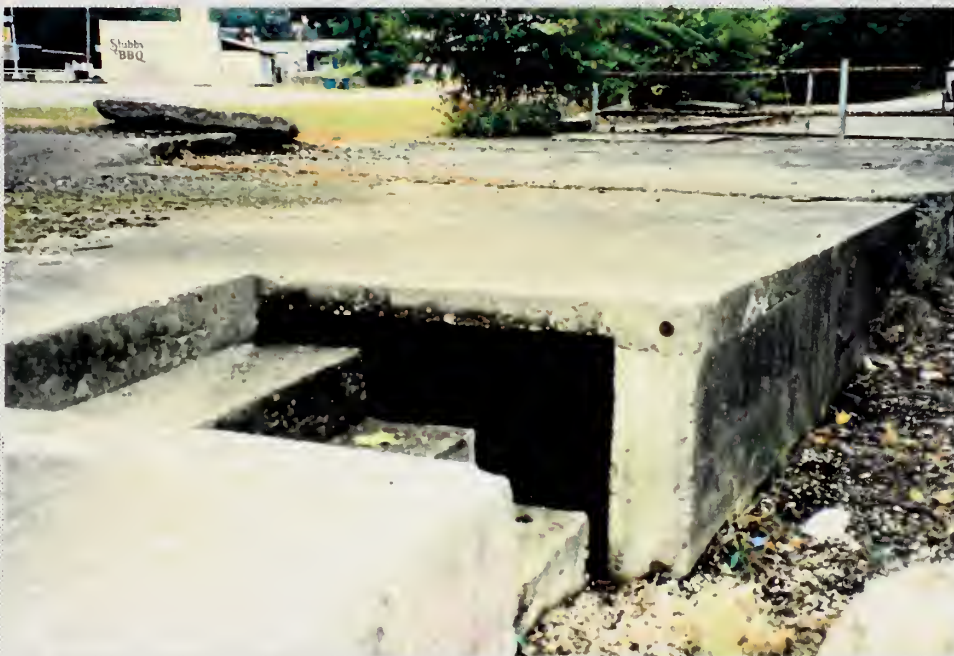
3.12 Vault near Arbor and Loadstone. Unprotected opening and slab thickness are shown.

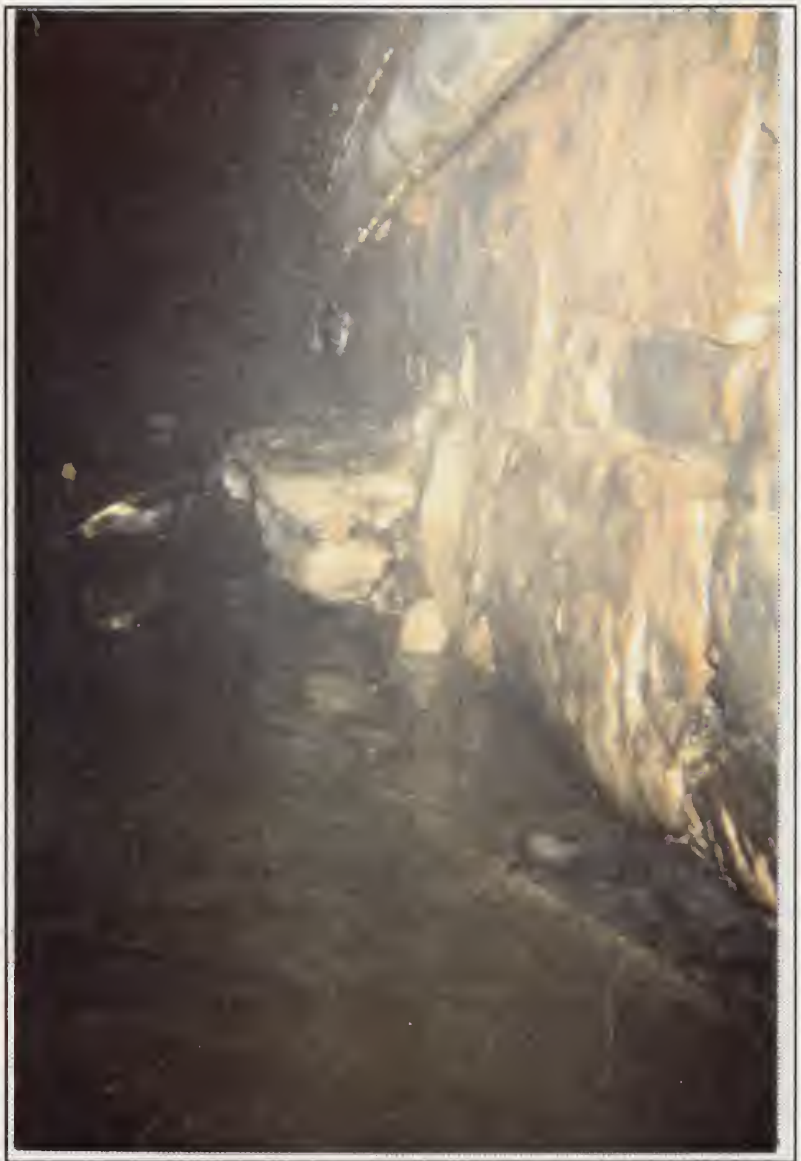
Erosion of the foundation of the sidewalls of the tunnel is a serious structural problem. Planning, engineering and budget programming to solve the problem should begin immediately. The worst areas of erosion should be identified and repaired within two years.

Photo 3.13 again shows erosion at the base of the sidewall of the tunnel. This photo was taken in a section upstream of the Fordyce Bathhouse Visitor's Center. Again the masonry of the sidewalls appears to be in good condition.

3.13 Erosion of the Base of the Sidewalls of the Tunnel.
Erosion of previously placed concrete is visible.
(About Sta. 240+00)
